## SEAGLIDER TESTS AND MISSIONS DURING 2013

R. GERIN, E. MAURI, P. ZUPPELLI,  
S. KUCHLER, P.-M. POULAIN and A. BUSSANI

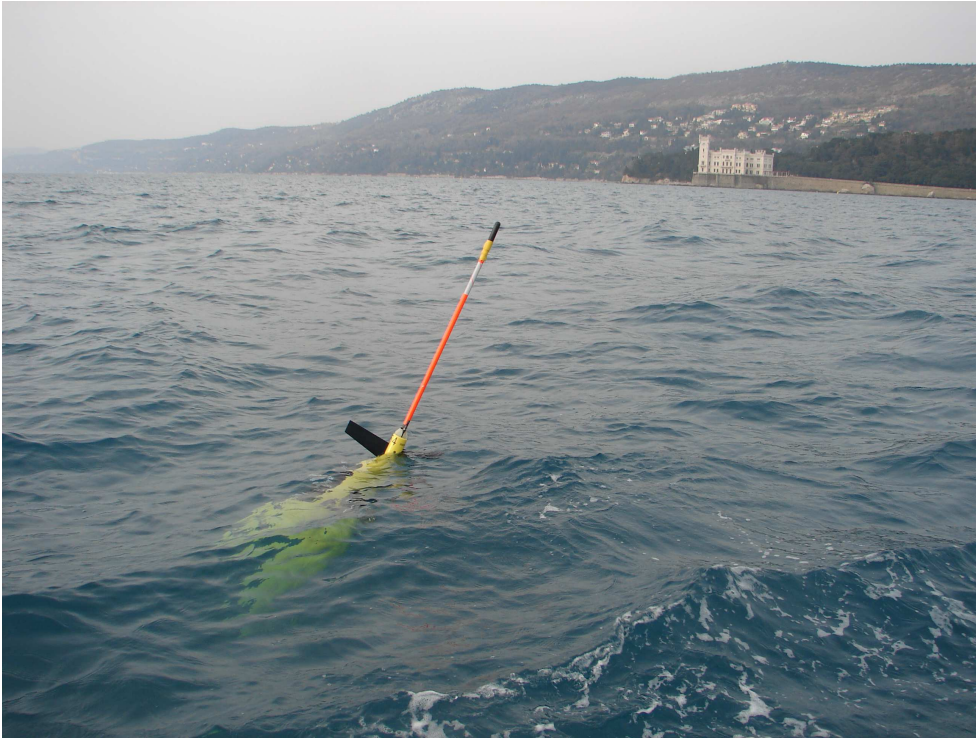
Fig. 1. The SeaGlider at surface in the Gulf of Trieste with the Miramare castle in the background.

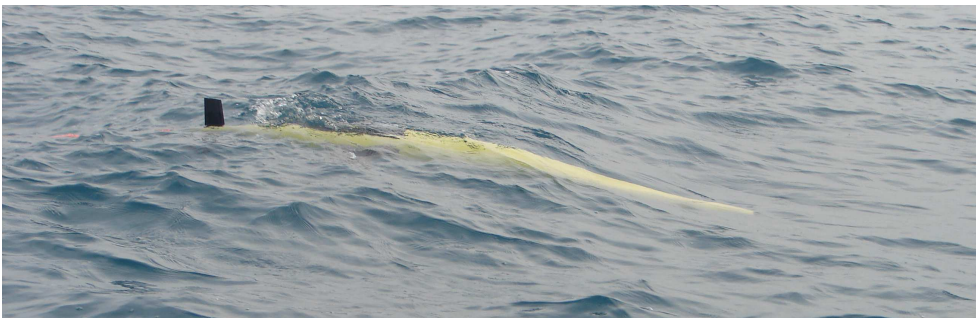
Fig. 2. The SeaGlider during the dive-phases. It lays horizontally at the surface or it is slightly submerged.

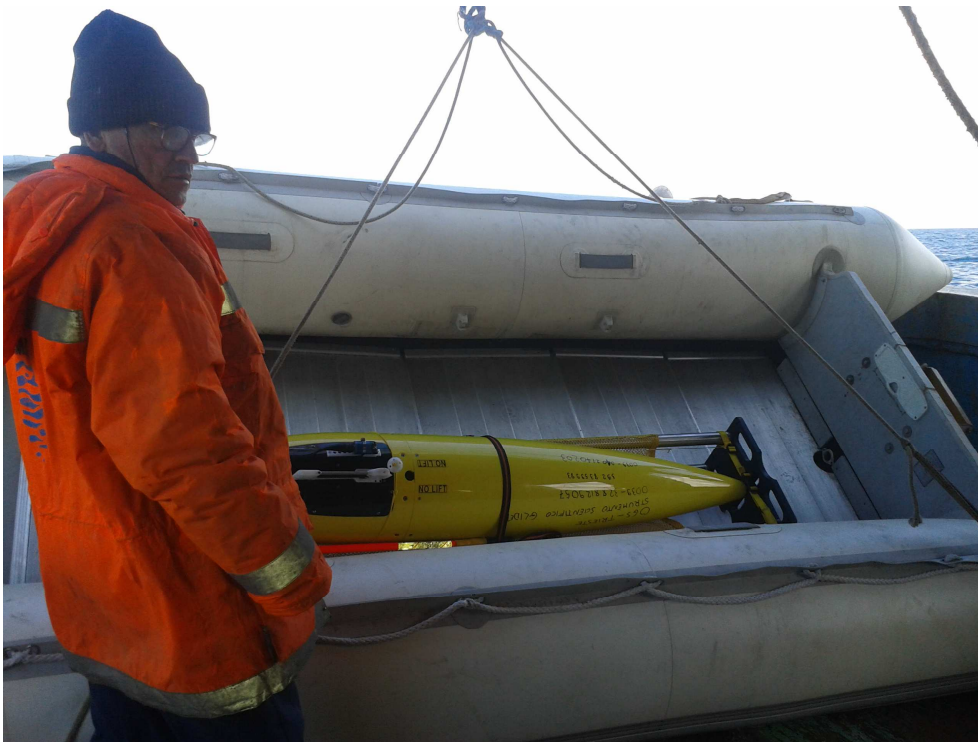
Fig. 3. The SeaGlider fastened inside the rubber boat before the deployment.

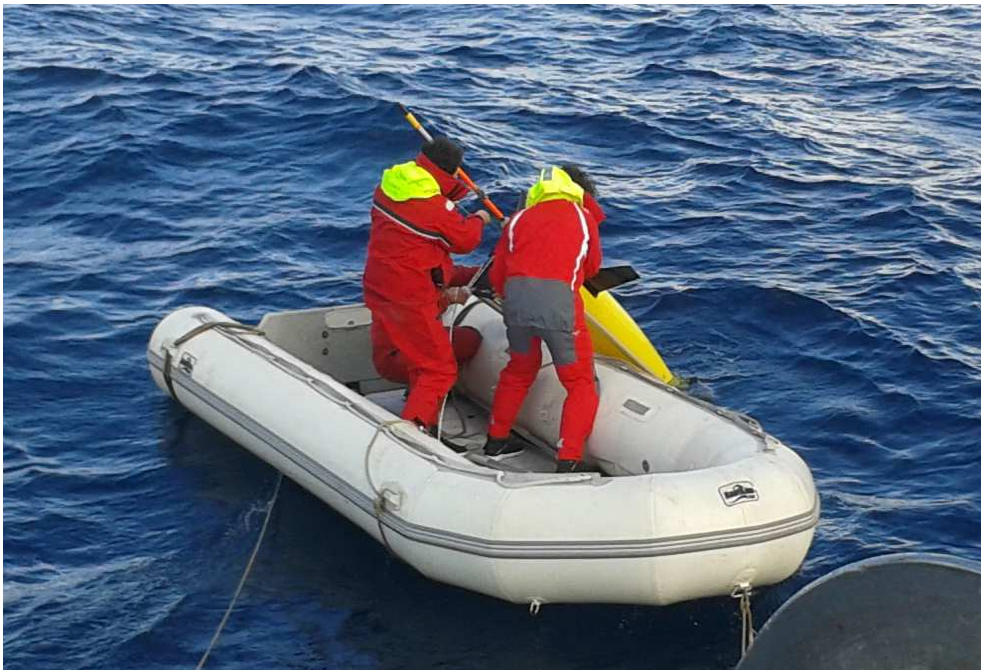
Fig. 5. The SeaGlider on the cradle before the deployment.

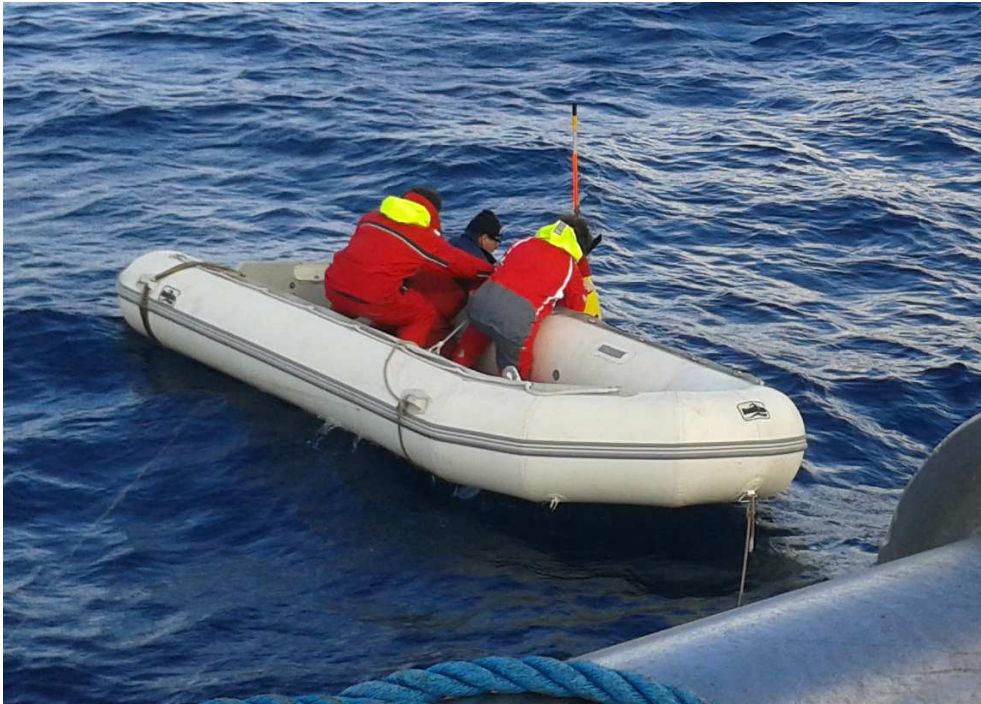
Fig. 6. The SeaGlider in water with the cradle

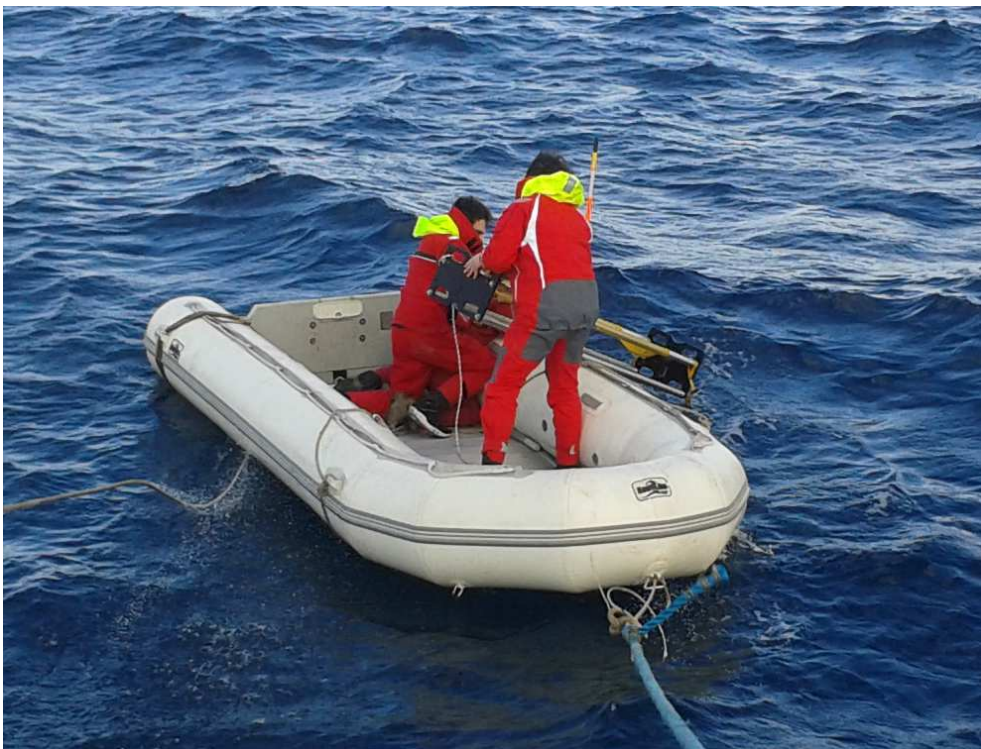
Fig. 7. The SeaGlider in the water freed from the cradle.

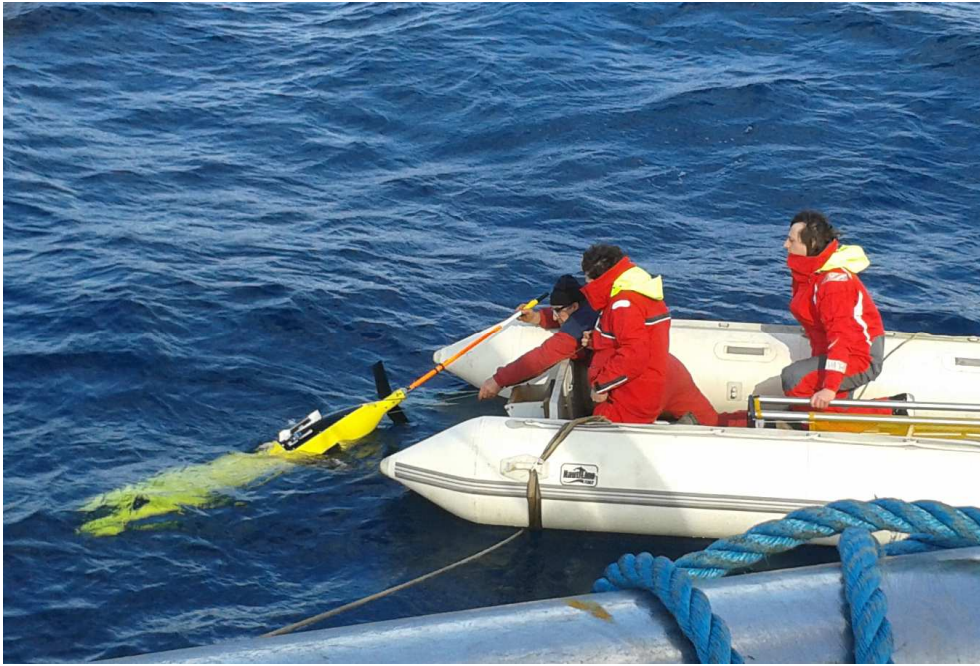
Fig. 8. The SeaGlider in water in surface-mode.

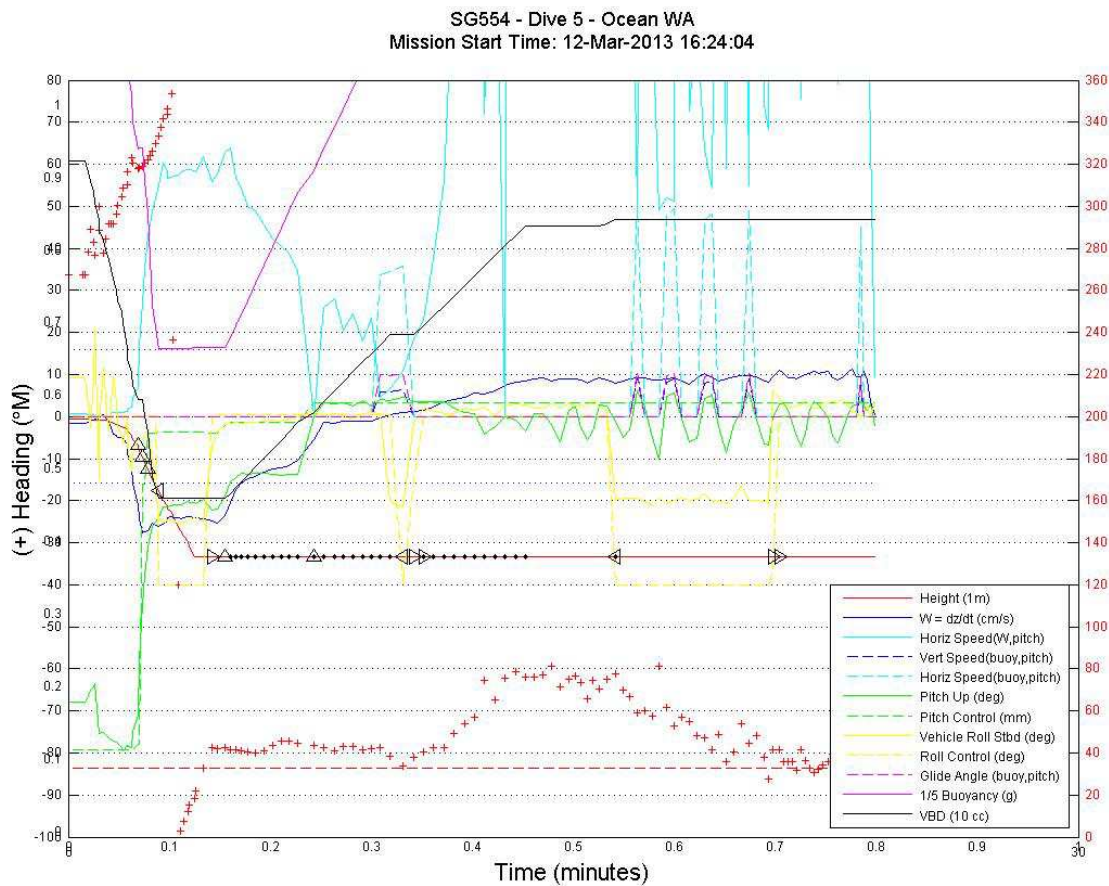
Some major problems occurred when parameters used in the glider trimming were partially displayed or not displayed at all in the plots generated by the `iRobot` scripts. At the beginning of the mission the transmission occurred regularly for the first 6 surfacings but then some parameters after the apogee manoeuvre (or even before, Fig. 9) were displayed constant in time. The problem increased after the 6<sup>th</sup> dive when randomly some plots were not generated at all, making the glider team unable to trim the glider. After some investigation it was found that the missing display of the data was due to the presence of a lot of NaNs in the WetLab sensor outputs. Furthermore, the glider went

Fig. 9. Plot of the technical parameters. The depth is plotted only down to 33 m, but the glider reached 52 m as shown in the ppc\*\*\*\*\*.eng files. No climbing phase is displayed.

After some e-mails exchanged with the people at iRobot, the \$PITCH\_GAIN was changed from 45 to 40 (dive 14), with no particular improvement. Due to all those failures and since the depth in the area is about 100 m, not allowing the glider to go deeper in order to increase its speed and to steer the glider far from the coast, during the night we decided to recover the instrument. The recovery occurred on 13/03/2013 at 10:37 GMT at 41.221°N – 16.906°E (glider icon in Fig. 10).

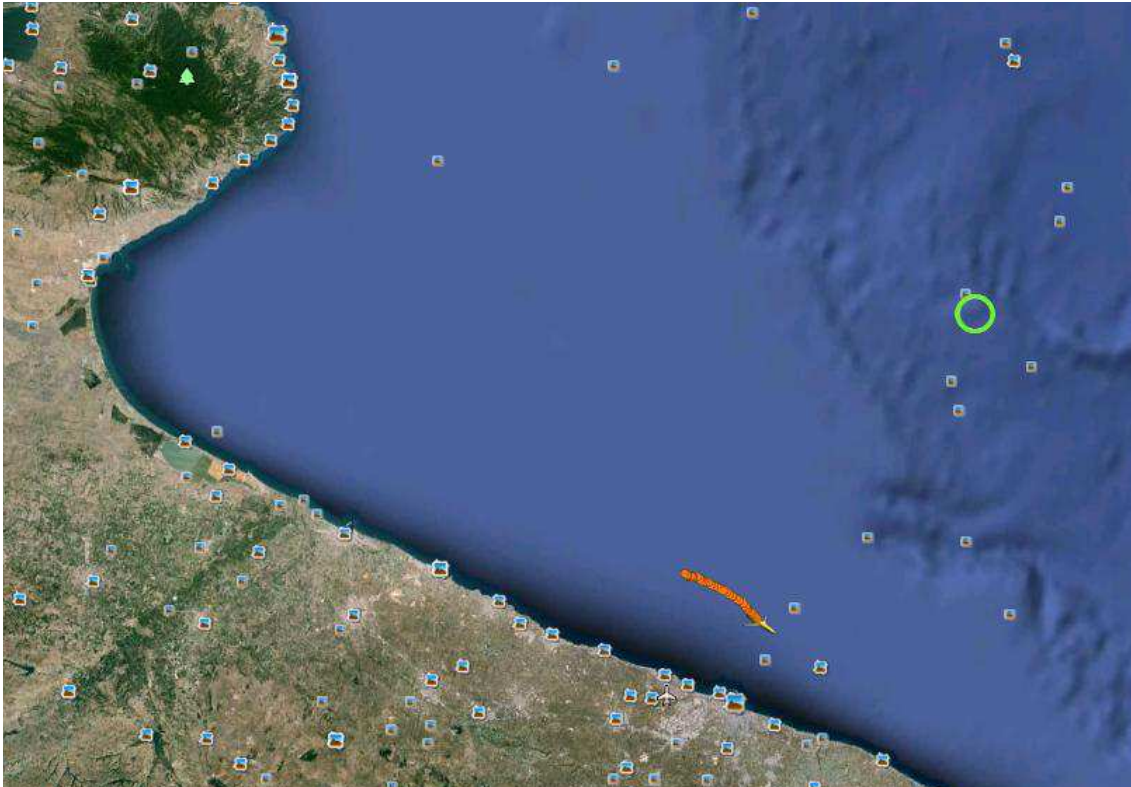
deeper than the planned 40 m and moved parallel to the coast due to a strong current instead of heading to the waypoint (Fig. 10).

Fig. 10. Glider mission: surfacings (orange points), last position (glider icon) and waypoint (green circle).

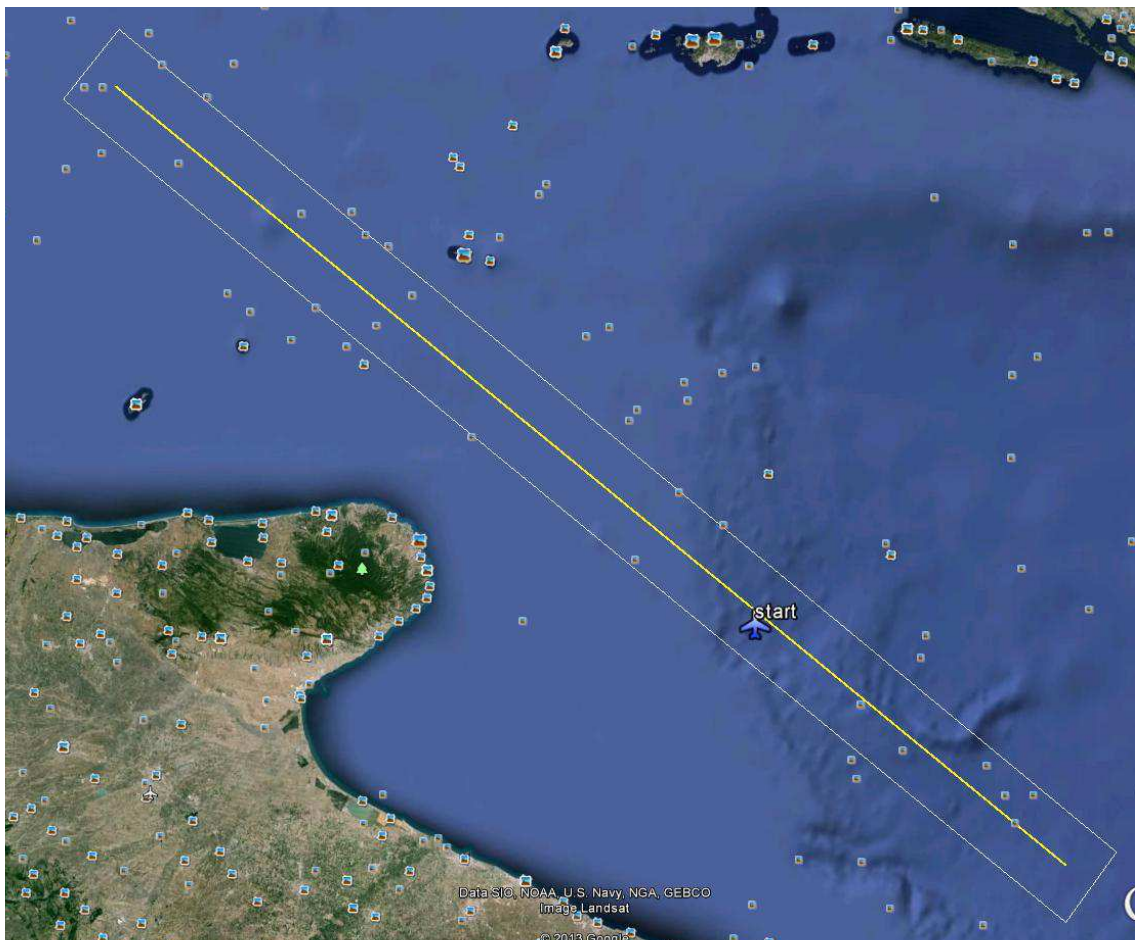
Fig. 14. Planned glider mission in May 2013.

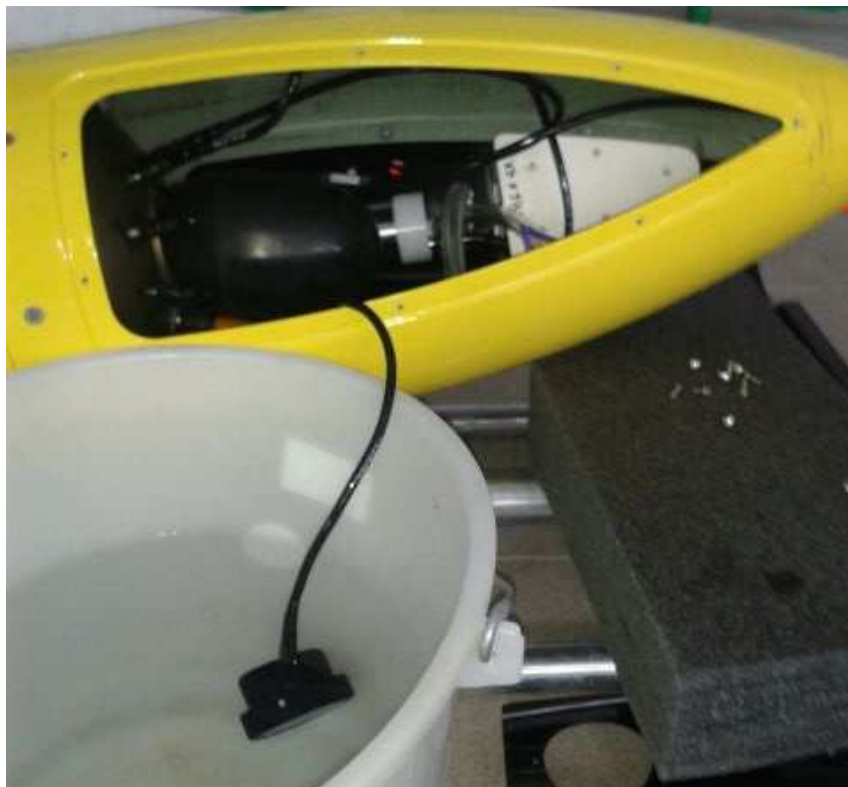
Since glider data of a few dives were not transmitted via iridium in real-time, all the files acquired during the mission were manually downloaded in the Lab following Zuppelli and Kuchler (2013). Data were analyzed and NaNs were again found in the WetLab data. The sensor connectors were inspected and some water intrusion again was discovered. The connectors were cleaned and both the sensor and the cable were deeply tested in the laboratory. No damage on the cable was found and the sensor passed all the functional tests. The connectors on the glider side demonstrated to be a weak point of the WetLab sensor. It was decided to better protect them for the future missions by using liquid tape.

Fig. 15. WetLab sensor test.

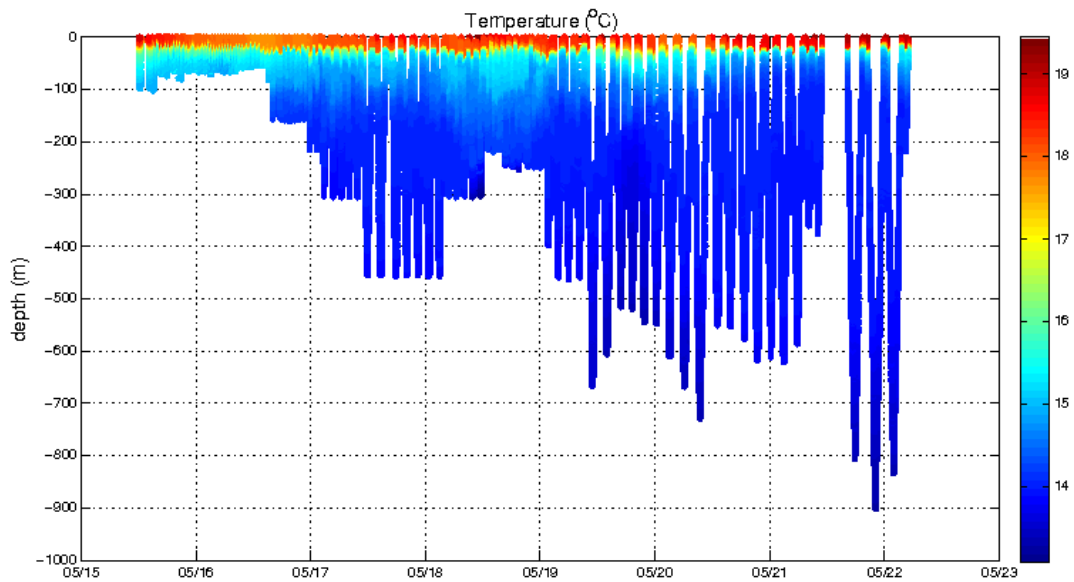
Fig. 16. Temperature.

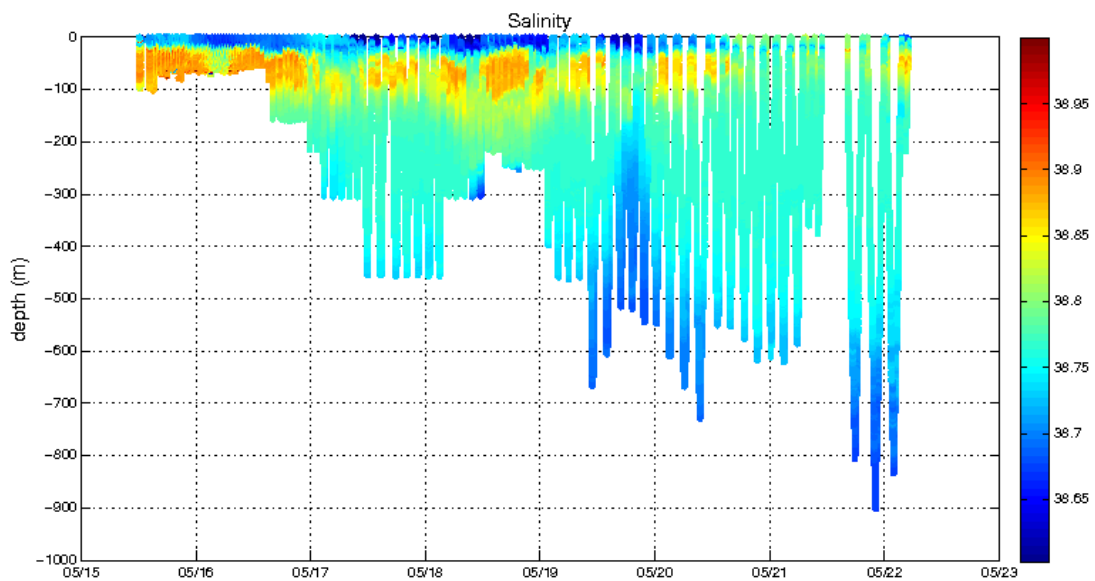
Fig. 17. Salinity.

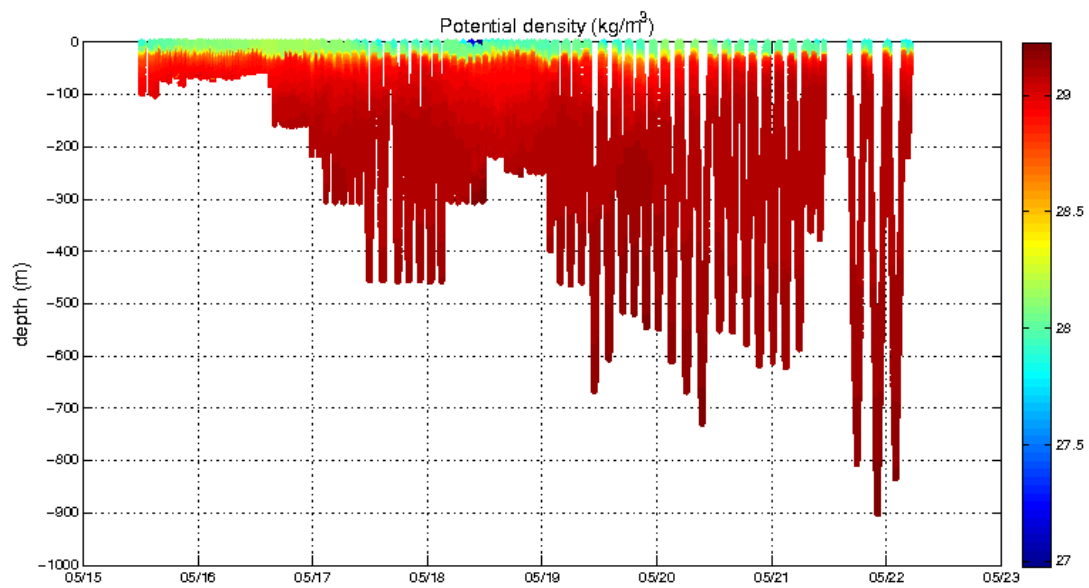
Fig. 18. Potential density.

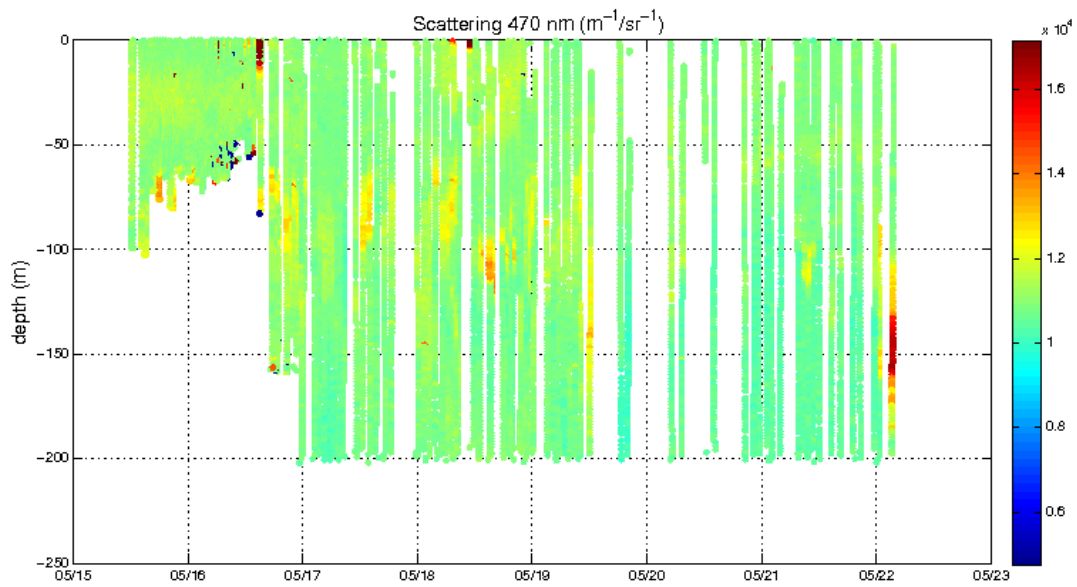
Fig. 21. Scattering at 470 nm.

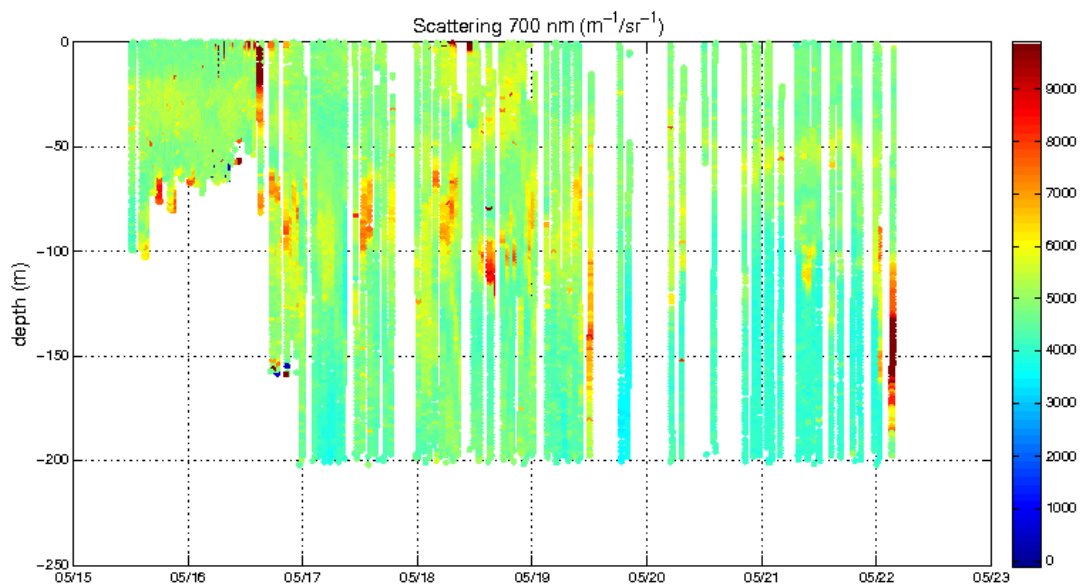
Fig. 22. Scattering at 700 nm.
