**GLIDER EXPERIMENT IN THE LIGURIAN SEA AS PART OF
MREA08 (LA SPEZIA, 30 SEPTEMBER – 23 OCTOBER 2008)**

R. GERIN

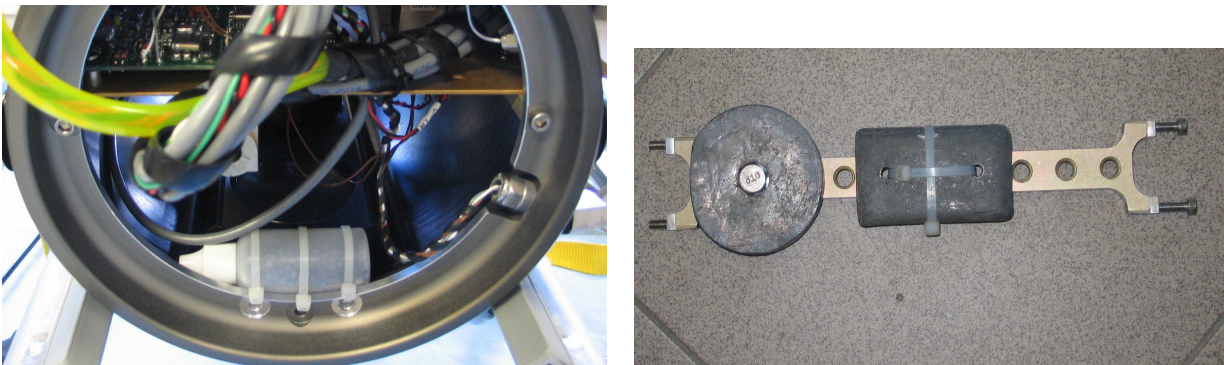
Fig. 2: Redistribution of the internal weights of the glider: bottle filled by plumb bobs (left) and load rail (right).

The glider preparation began in July 2008. Due to the intense glider use planned for the MREA08 missions, we decided to replace the battery (the autonomy guaranteed by the old battery was about 10-15 days). We took the advantage of this change, and the consequent redistribution of weights (see Fig. 2 and Table 1 for the details), to fix the hook (provided by the manufacturer Webb) on top of the mid hull section of the glider. The hook (Fig. 3) is very useful when the glider is handled or in case of recovery.

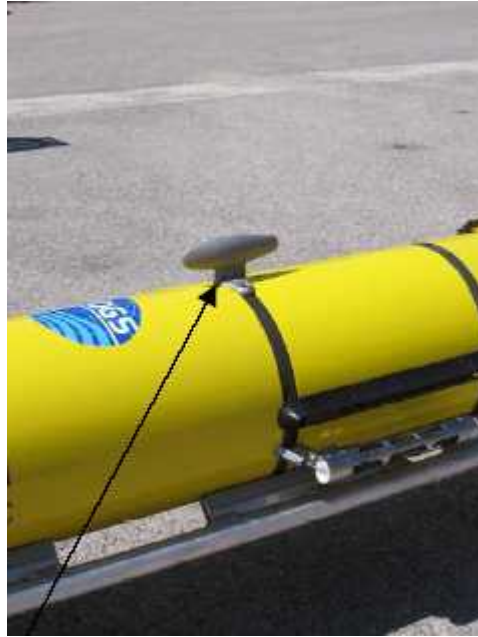
Fig. 3: The hook mounted on top of the mid hull section of the glider.

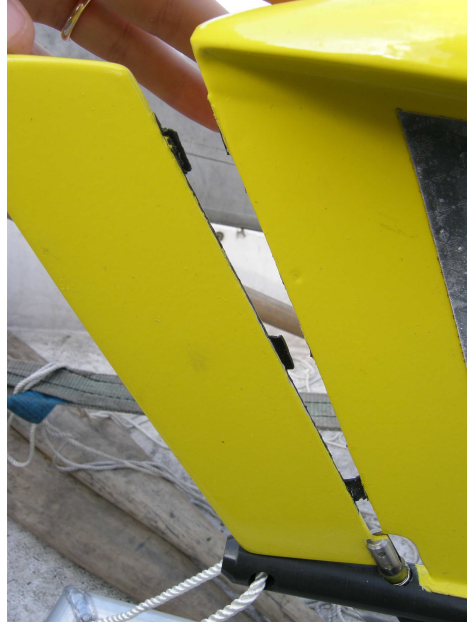
Starting from the 30th of September, we participated in the first leg of the R/V Ammiraglio Magnaghi cruise. As planned, the glider was deployed nearby the CTD1 point (at about 12:00 GMT). Unfortunately, during the testing operations, the security rope (see Medeot e Gerin, 2007) slid into the space between the fixed and the mobile part of the rudder cutting two

of its rubber hinges (Fig. 4). Considering the total duration of the other two glider missions, we decided to come back to OGS and to repair the rudder there.

Fig. 4: The damage occurred on the rudder during the first leg.

The rudder was repaired by attaching a plastic hinge (of model aircrafts) using polyester resin. During the laboratory tests, we discovered that the air bladder did not inflate. Upon opening the glider, few drops of salty waters were found inside the tygon tube joining the air pump system to the bladder (Fig. 5). Additionally, dry salty water was found directly below the electrovalve which drives the inflation of the air bladder. After a careful inspection, we discovered that the electrovalve was blocked in the “always open” position. The electrovalve was replaced by another one taken from an Apex float.

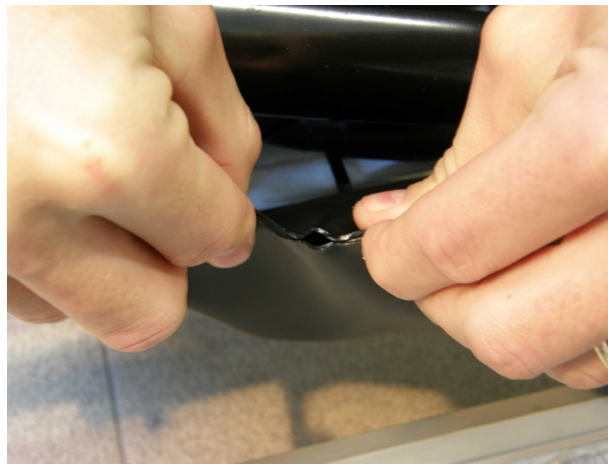
After other tests on the electrovalve and on the air bladder, we realized that there was a leak at the air bladder seam (Fig. 6).

Fig. 6: The leak in the air bladder.

The Webb company was contacted immediately and they rapidly provided us with all the needed spare parts. The air bladder and the entire air pump system were replaced with the new elements and the vacuum inside the glider was monitored for one day to make sure that there was no leakage.

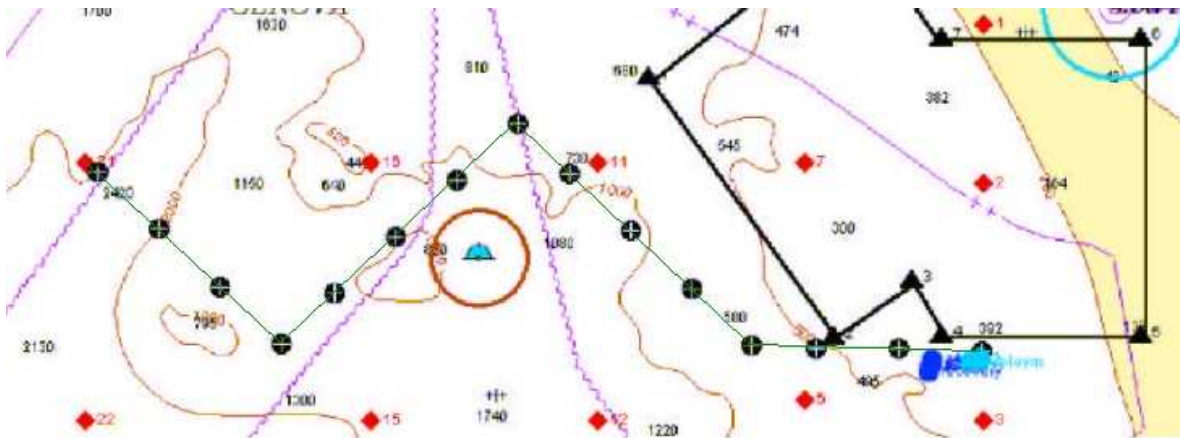
On the 20th of October we embarked again on the R/V Ammiraglio Magnaghi for the 3rd leg. The planned point of deployment was forbidden because of Italian Navy submarine activity, hence we decided to move the initial point of the glider path southward, deploying the glider in free waters (43°44.020'N - 9°41.890'E). Additionally, due to the limited ship time, we shortened the glider path (compare Fig. 1 and Fig. 7)

Fig. 7: The path of the glider as planned during the 3rd leg. Planned zig-zag path (green line); surfacing points (every 6 hours; black dots with white plus); forbidden area (black line bounded by the black triangle); CTD stations (numbered red rhombus); real glider course (regularly at surface: light blue dots; during abort: dark blue dots).

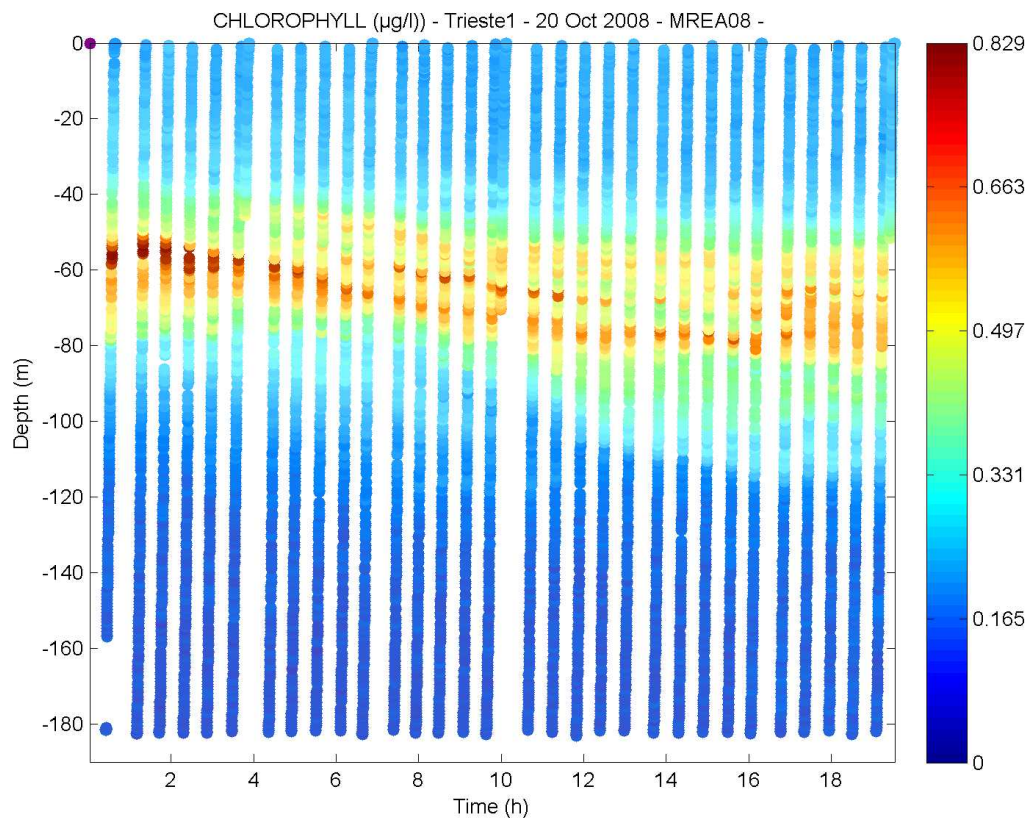
Fig. 17: Chlorophyll profiles. It displays the maximum below the thermocline.

During the last mission, the glider covered 9 nm and performed 31 complete yos down to 180 m. The following figures (from Fig. 12 to Fig. 18) report the profiles as recorded by the glider (one dots every two, color coded by parameter). The thermocline is recognizable at 40 m and it became deeper (down to 50 m) close to the coast (right hand side of the plots). The salinity graph (Fig. 13) display a core of fresh water in correspondence to the thermocline. The oxygen and the saturated oxygen plots (Figs.15 and 16) show a maximum in correlation to the thermocline, while the chlorophyll maximum (Fig. 17) is below the thermocline. Finally the turbidity plot (Fig. 18) is very scattered.
