The PreConvex16 and Convex16 glider missions in the South Adriatic Sea (November 2015 and April 2016)

R. GERIN, E. MAURI, A. BUSSANI, P. ZUPPELLI, S. KUCHLER,
Z. KOKKINI, M. PACCIARONI and P.-M. POULAIN

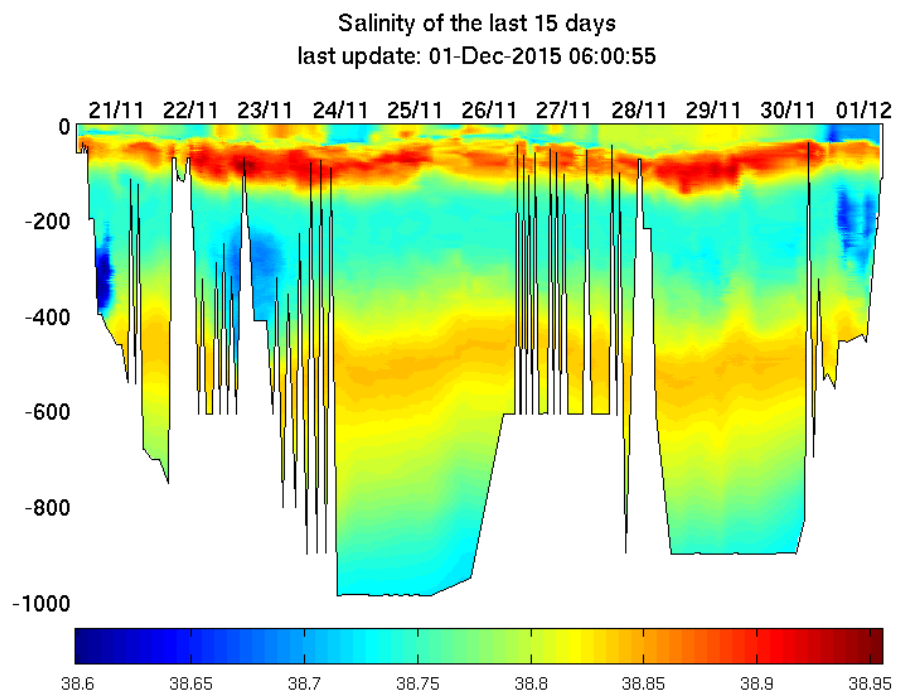
Fig.3 Salinity versus time.

The temperature data collected during the mission showed well stratified conditions in the top 100 m (Fig.2). Filaments of cold water were crossed along the coastal Italian water. A maximum salinity layer is present at around 100 m (Fig.3). A nucleus of low salinity, located in the center of the pit between 200 and 400m, was crossed on November 23. Other deep low salinity nucleuses were also sampled along the Italian coast. A second high salinity layer is present between 400 to 600 m.

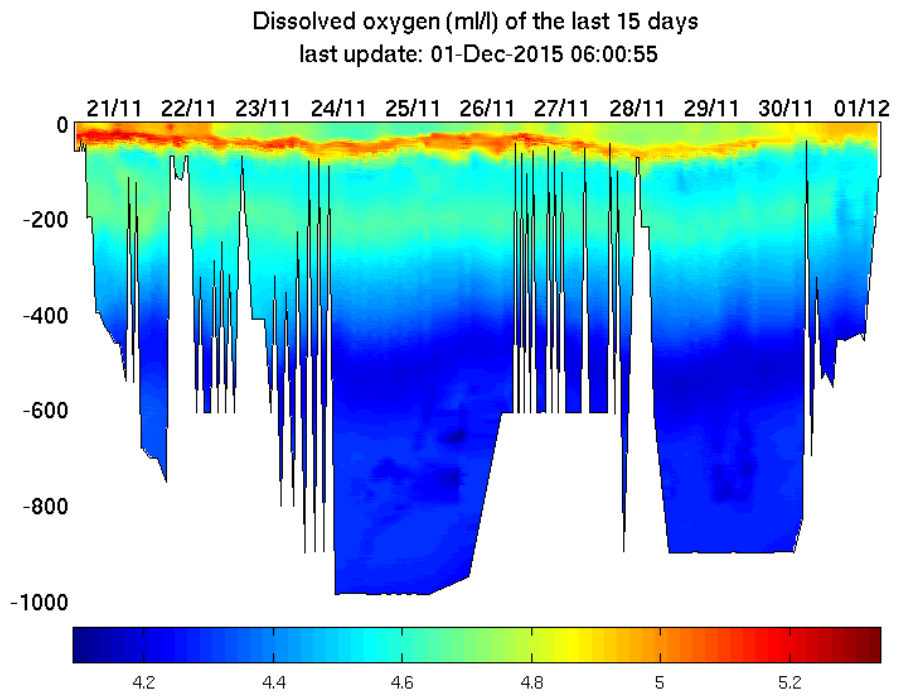
Fig.4 Oxygen versus time.

The maximum oxygen concentration is observed on top the sub-surface salinity maximum layer (Fig.4).

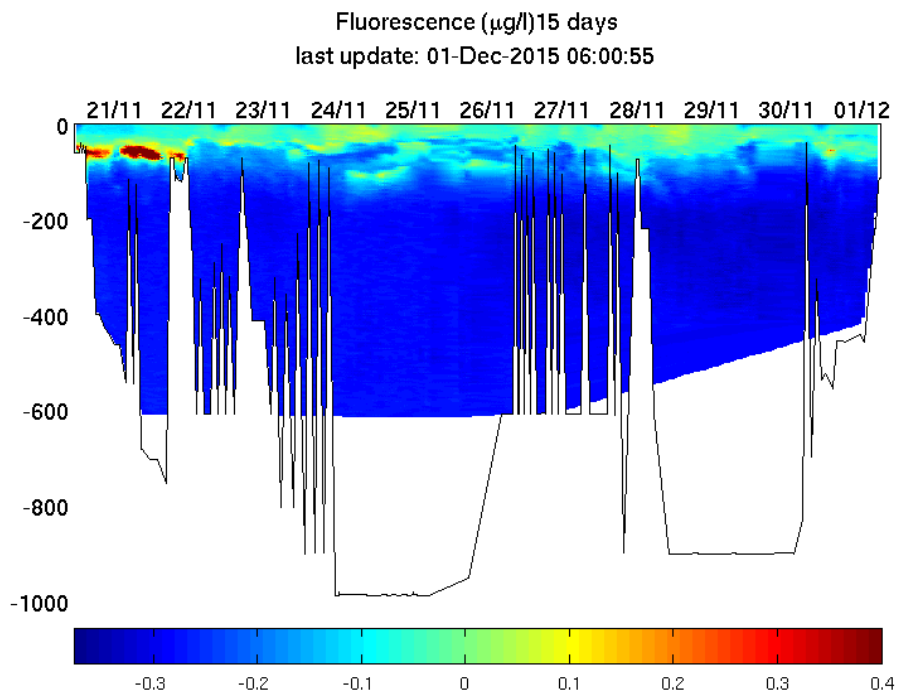
Fig.5 Fluorescence versus time.

Fluorescence depicts patchy distribution of chlorophyll in the top 80 m (Fig.5). The back-scatter plot (Fig.6) displays high values in correspondence of the WAC along the Italian coast. Low CDOM values (Fig.7) are depicted along the glider transect on the way back (from Dubrovnik to Bari). The maximum depth of acquisition for the optical sensor was changed during the mission (from 600m to 400m), consequently the interpolation displayed from 26/11 below 400m is an artefact (Fig.5, Fig.6 and Fig.7).

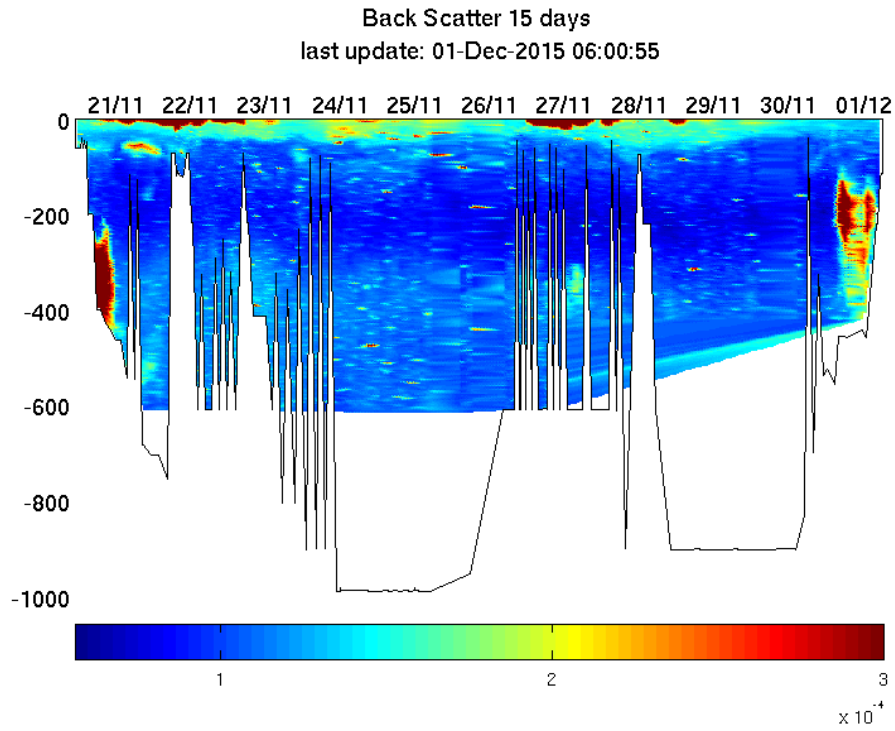
Fig.6 Back-scattering versus time.

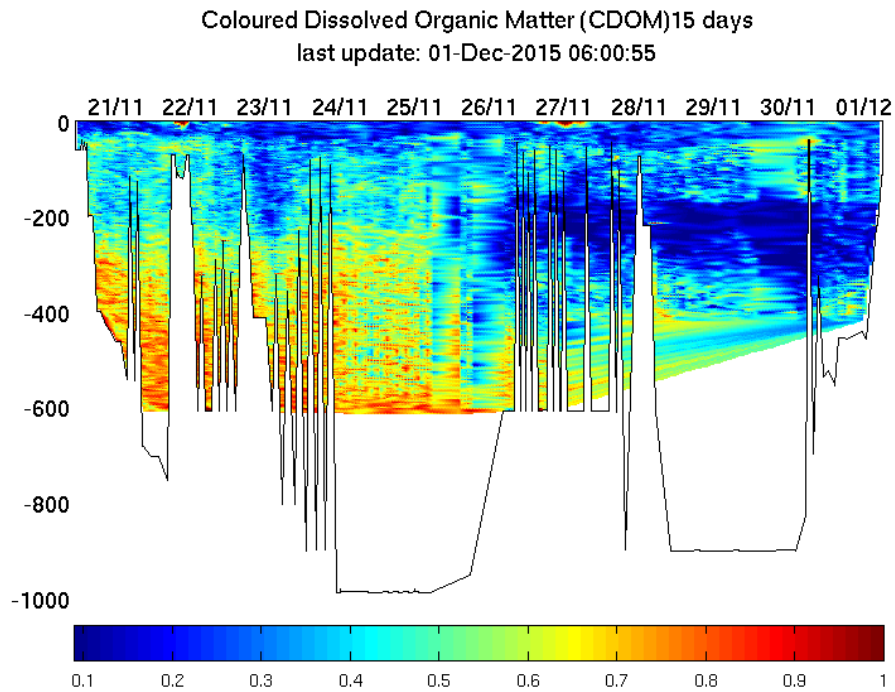
Fig.7 CDOM versus time.

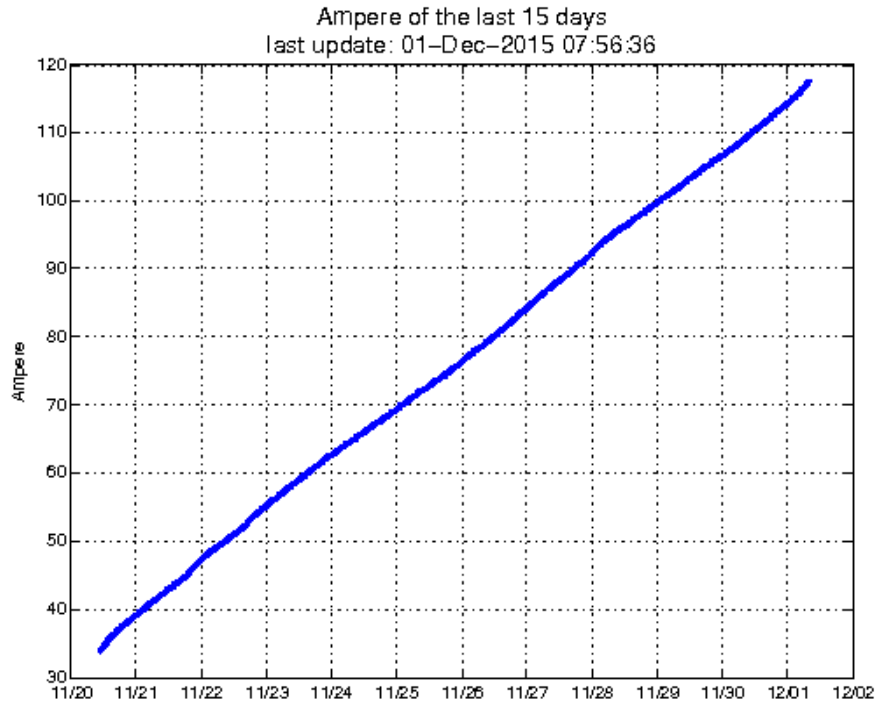
Fig.9 Ampere consumption of the glider during the mission.

The battery consumption for the 10-day mission was about 85 A (Fig.9) and the voltage dropped from about 13.6 V to about 12.1 V (Fig.10). The measured heading varied within about 20 degrees from the commanded heading (Fig.11). The vacuum was between 7 and 7.5 inHg while the glider was navigating underwater and around 9 inHg when the glider was at surface (Fig.12). No leakage was detected during the mission (Fig.13). The pitch and vertical velocities plots (Fig.14 and Fig.15) show a glider finely ballasted.

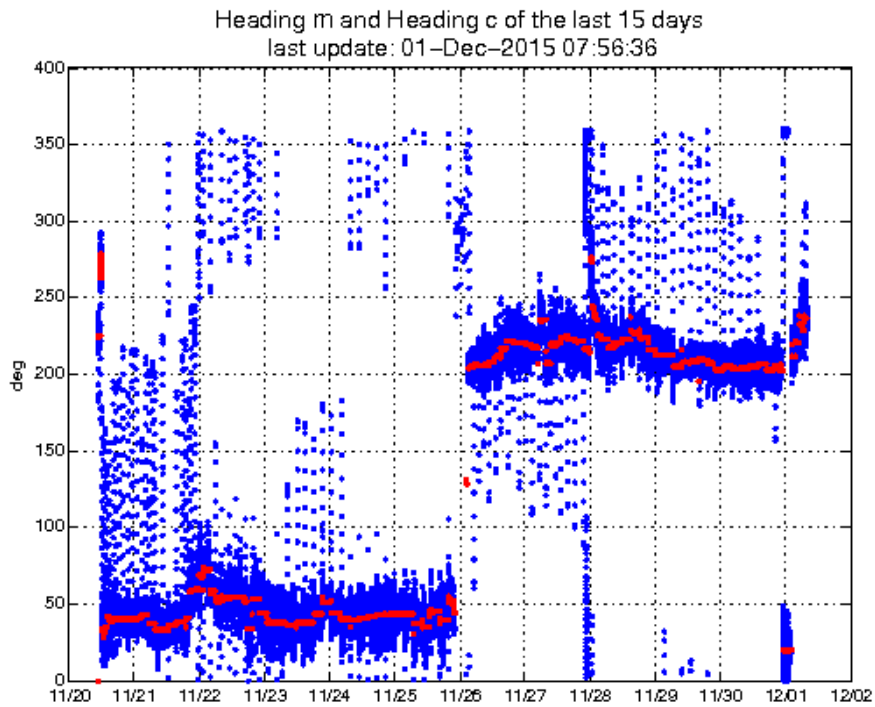
Fig.11 Commanded heading (red) and measured heading (blue).

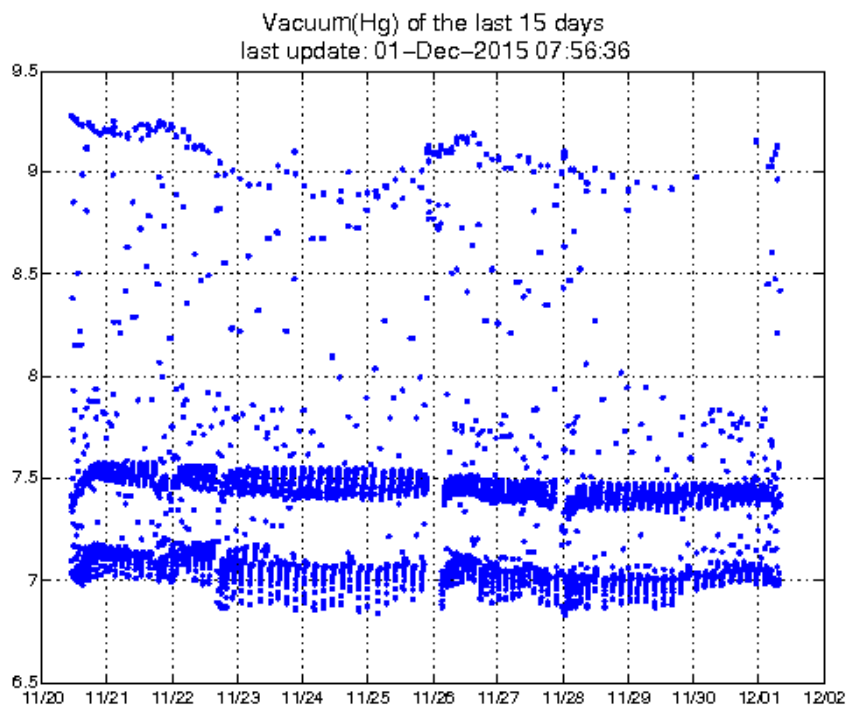
Fig.12 Internal vacuum of the glider during the mission.

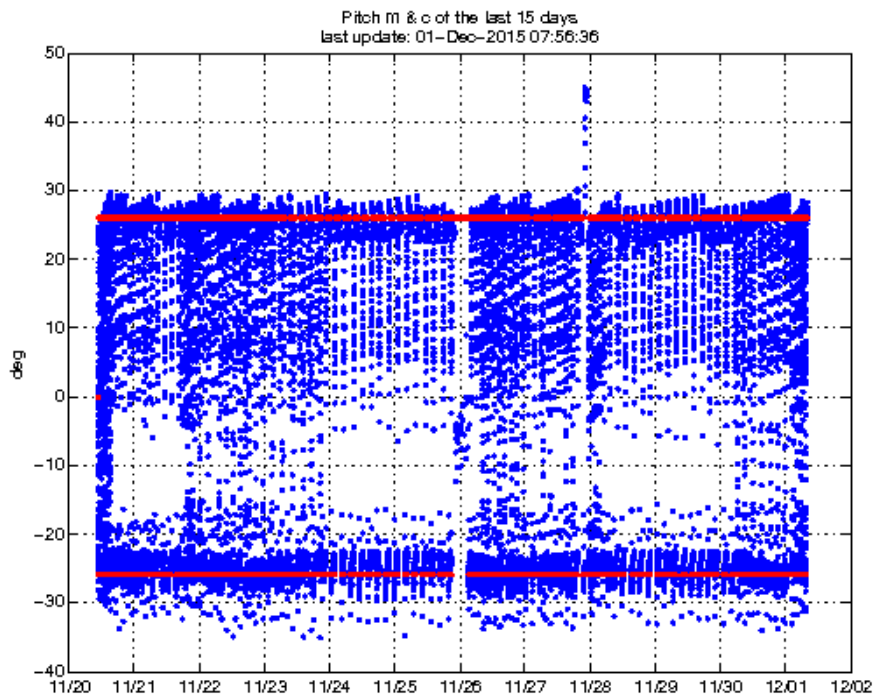
Fig.14 Commanded pitch (red) and measured pitch (blue).

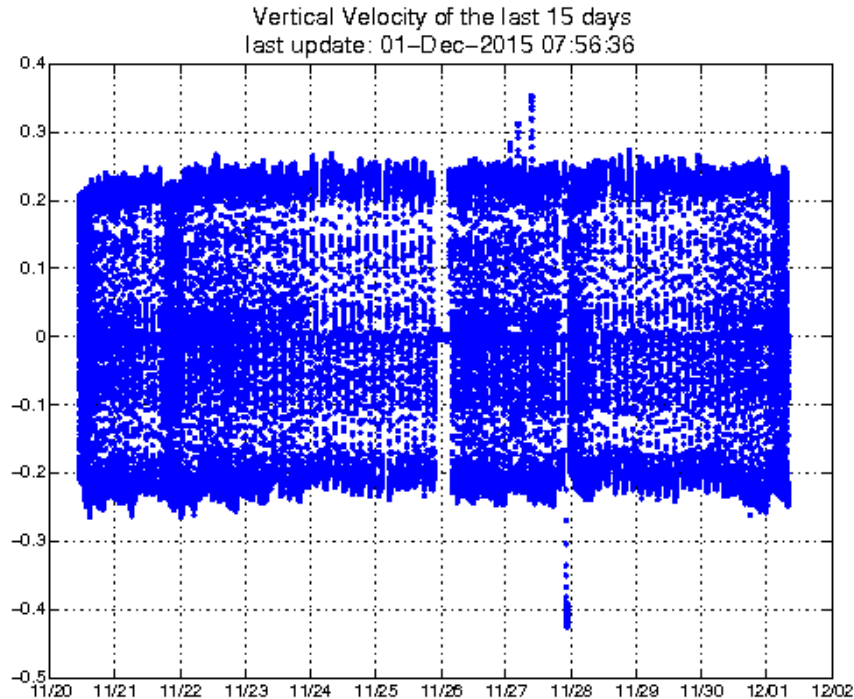
Fig.15 Vertical velocity of the glider as computed by the internal Persistor.

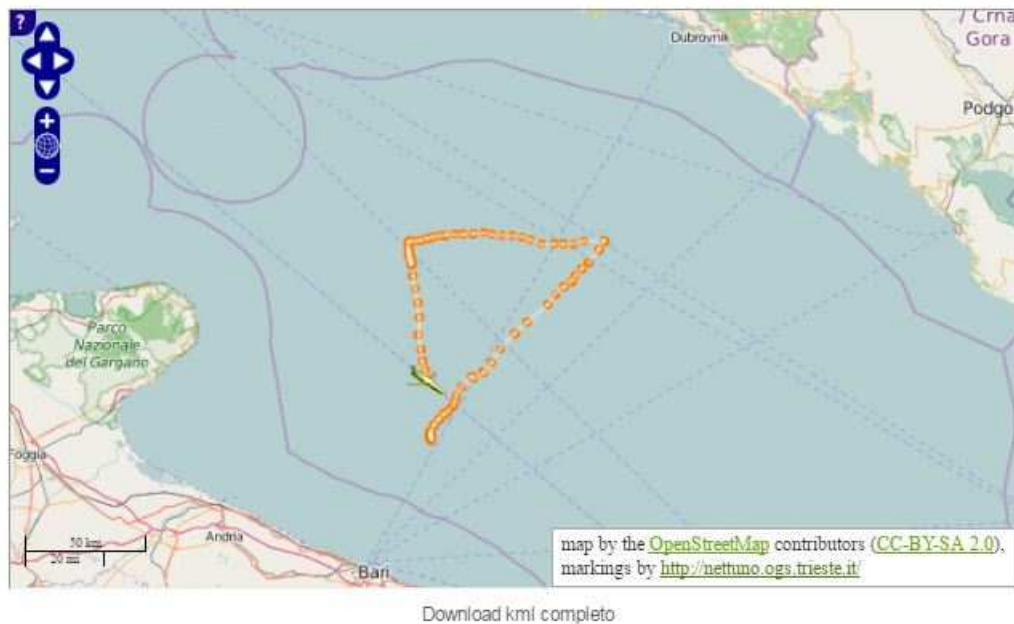
Fig.18 The glider trajectory; the deployment and recovery was performed off the Italian Coast. The glider icon indicates the recovery point.

The mission started on April 22, 2016 and ended 9 days later on May, 1. The track of the glider, depicted in Fig.18, follows a triangle with the first lag along the Bari-Dubrovnik transect then the glider turned to the west heading to the Gargano Peninsula and finally it headed south to the deployment point.

The glider was deployed on April 22 at 08:43:09 UTC at 41.503°N and 17.087°E. At the beginning, the instrument was steered along the transect Bari-Dubrovnik to the first way point at 42.067°N and 17.744°E, reached on April 26 at 11:42:30 UTC. The glider was then headed to the second way point located at 42.063°N and 16.998°E. The point was reached on April 29 at 03:10:09. The third way point was set at the same location of the deployment, the glider was recovered on the way to the waypoint at 41.673°N and 17.069°E on May 1 at 07:53:33 (Fig.18).

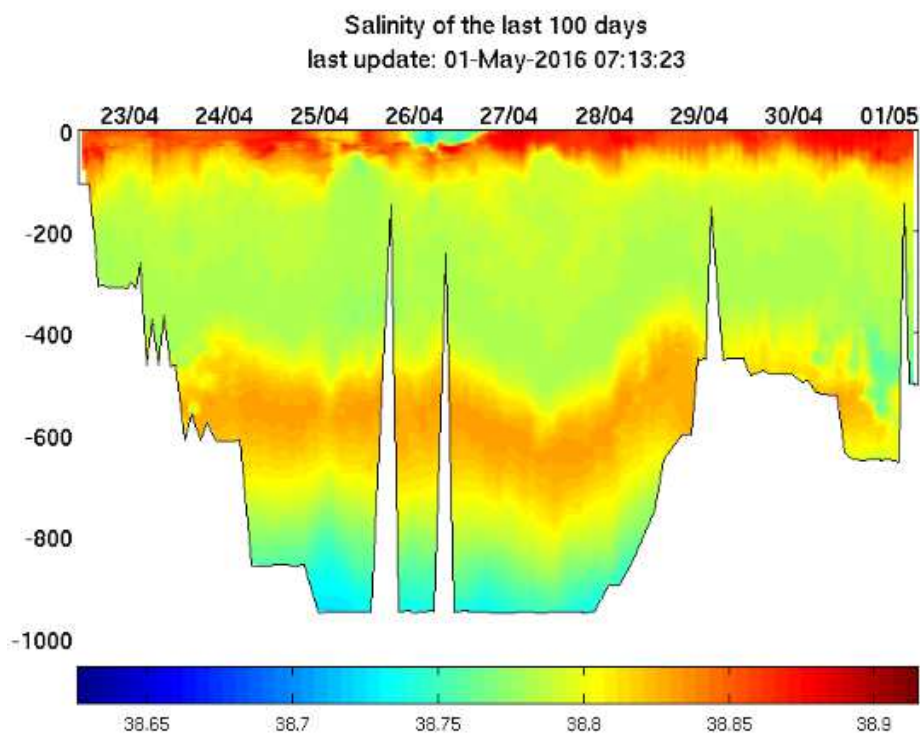
Fig.20 Salinity versus time.

A double salinity maximum is evidenced. One maximum can be observed at around 100 m, while the second maximum is located between 400 to 700 m. (Fig.20).

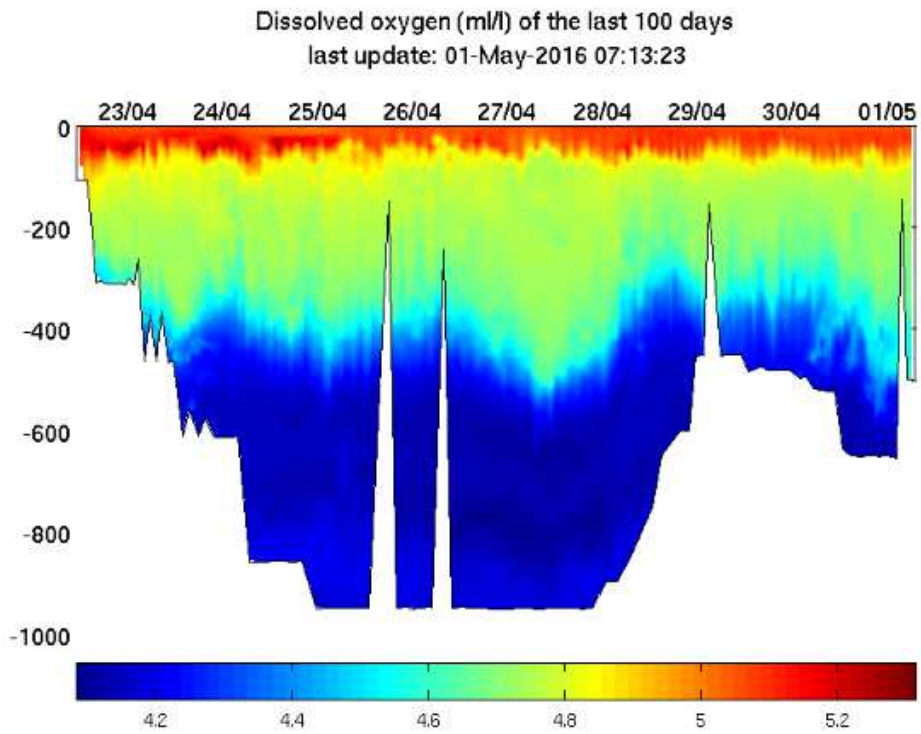
Fig.21 Figure 4: Oxygen versus time.

Higher oxygen concentration is present at the surface while minimum values are correlated to the deep maximum of salinity (Fig.21). The fluorescence plot shows the presence of a chlorophyll maximum at about 50 m (Fig.22). The back-scattering plot (Fig.23) displays the highest values at surface on April 25 and 26. The maximum value of the back-scattering seems to follow the maximum of the fluorescence. Low CDOM values (Fig.24) were found in correspondence of the high fluorescence value.

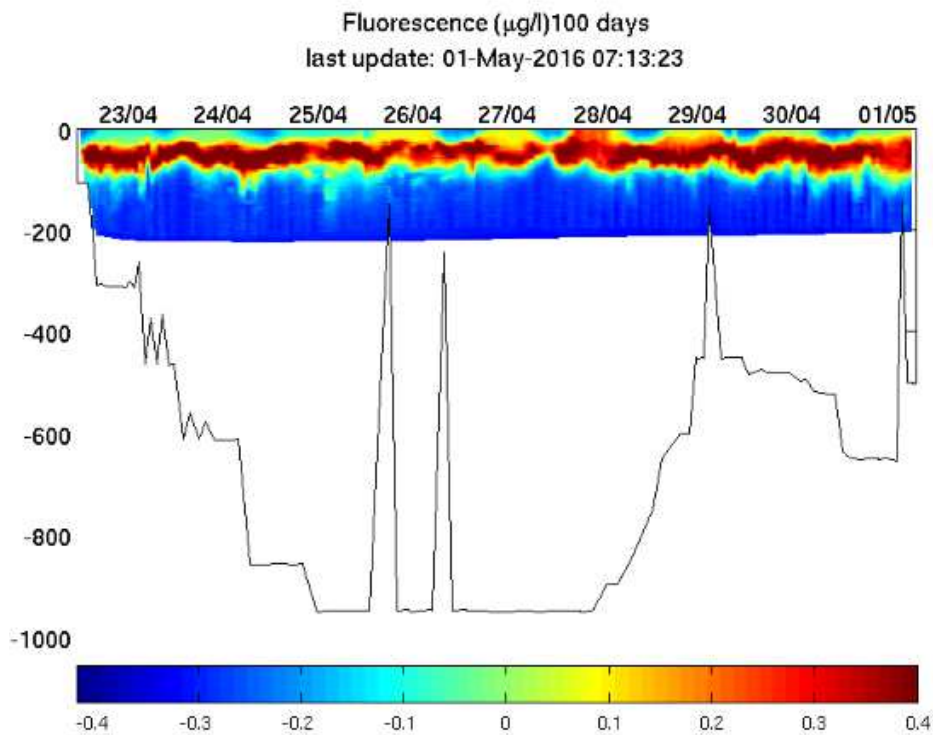
Fig.22 Fluorescence versus time.

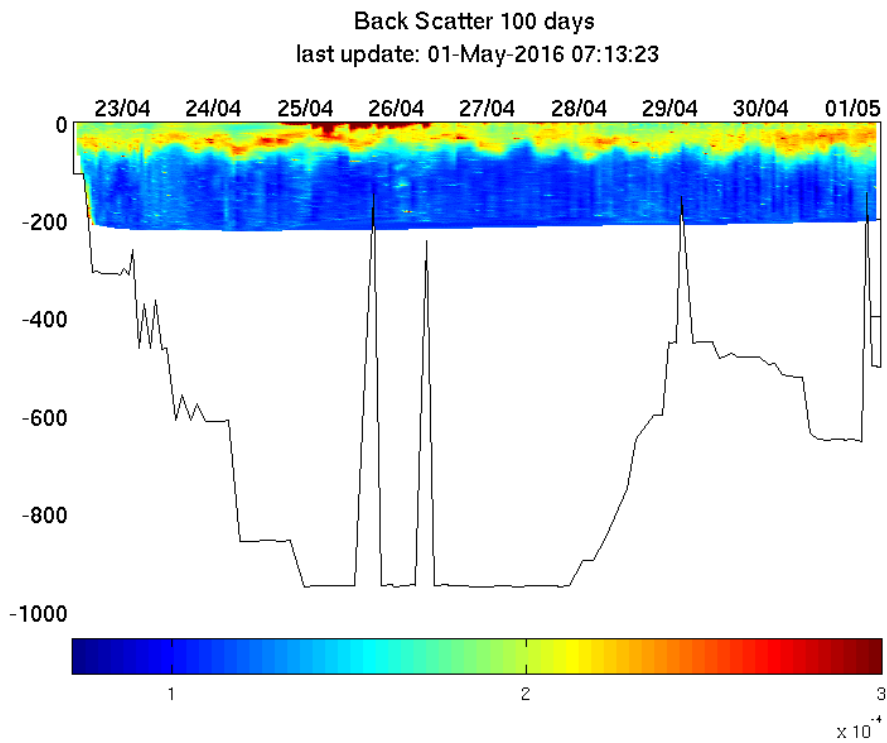
Fig.23 Back-scattering versus time.

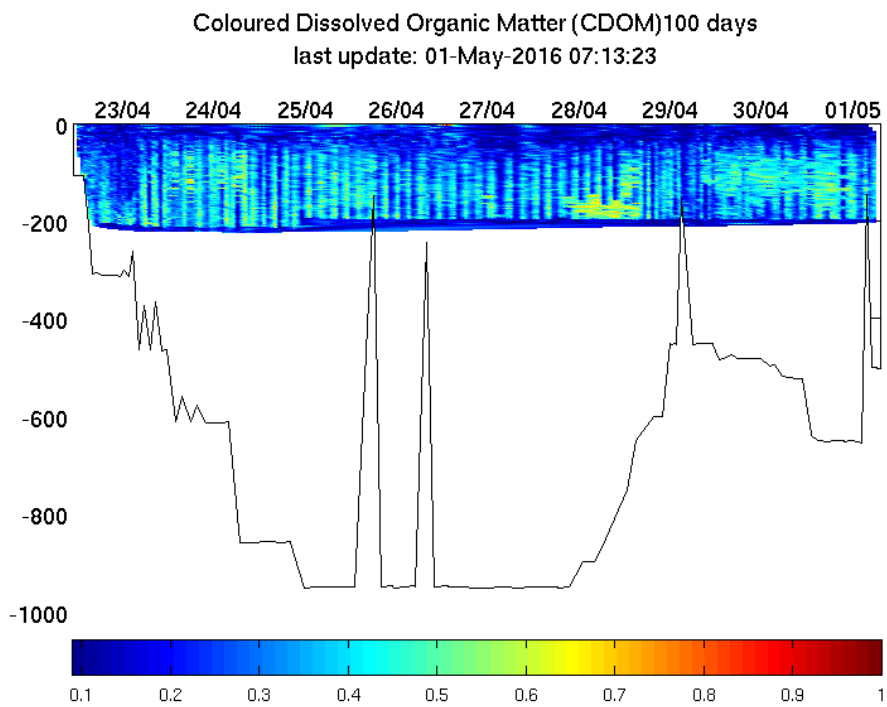
Fig.24 CDOM versus time.

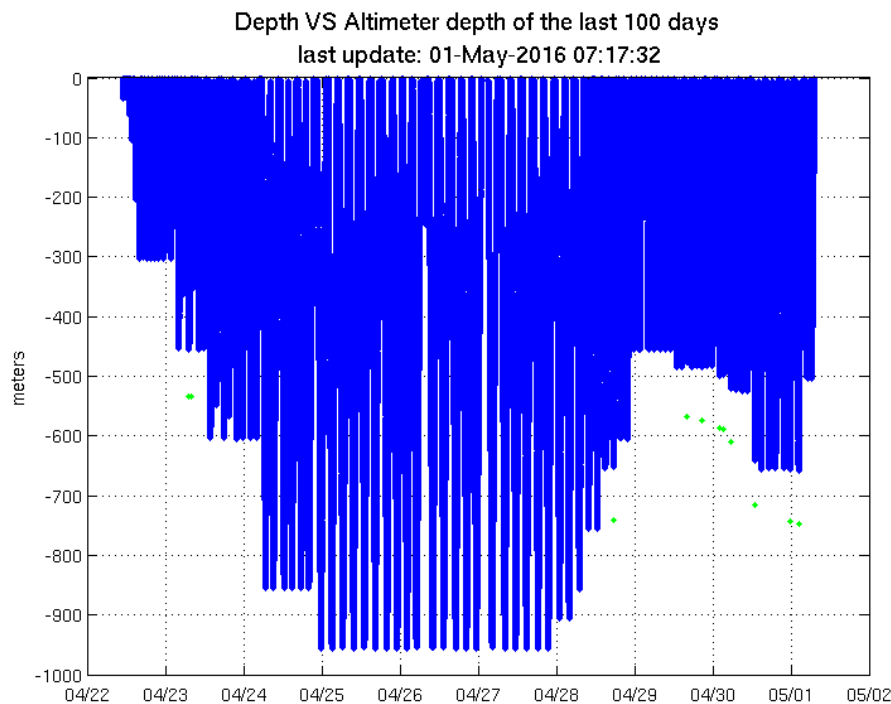
Fig.25 Glider depth (blue) and bottom (green) if recognized by the altimeter

The technical data recorded during the mission are depicted in figures from Fig.25 to Fig.32. The glider altimeter detected the bottom several times (green dots in Fig.25). The glider turned most of the time because it reached the `d_target_depth` and not because of the `d_target_altitude`.

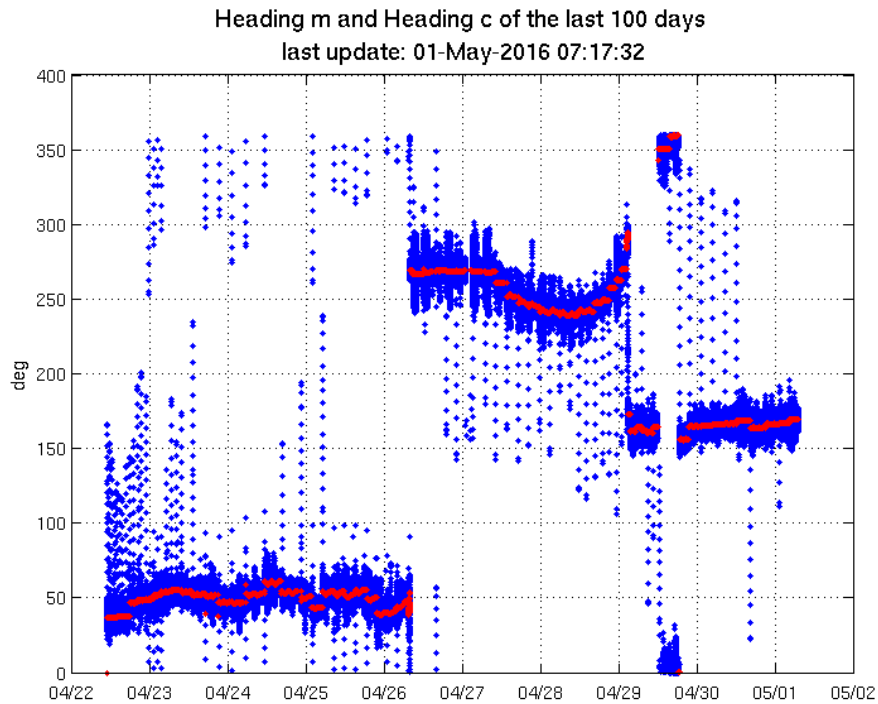
Fig.28 Commanded heading (red) and measured heading (blue).

The battery consumption for the 9-day mission was about 55 A (Fig.26) and the voltage dropped from about 15.1 V to about 13.3 V (new batteries; Fig.27). The measured heading varied within about 15 degrees from the commanded heading (Fig.28). The vacuum ranged between 6.9 and 7.4 inHg while the glider was navigating underwater and around 9 inHg when the glider was at surface (Fig.29). No leakage was detected during the mission and a decreasing trend of the measured voltages was observed (Fig.30). The pitch and vertical velocities plots (Fig.31 and Fig.32) show a well ballasted glider, slightly faster during the diving phases (positive velocities).

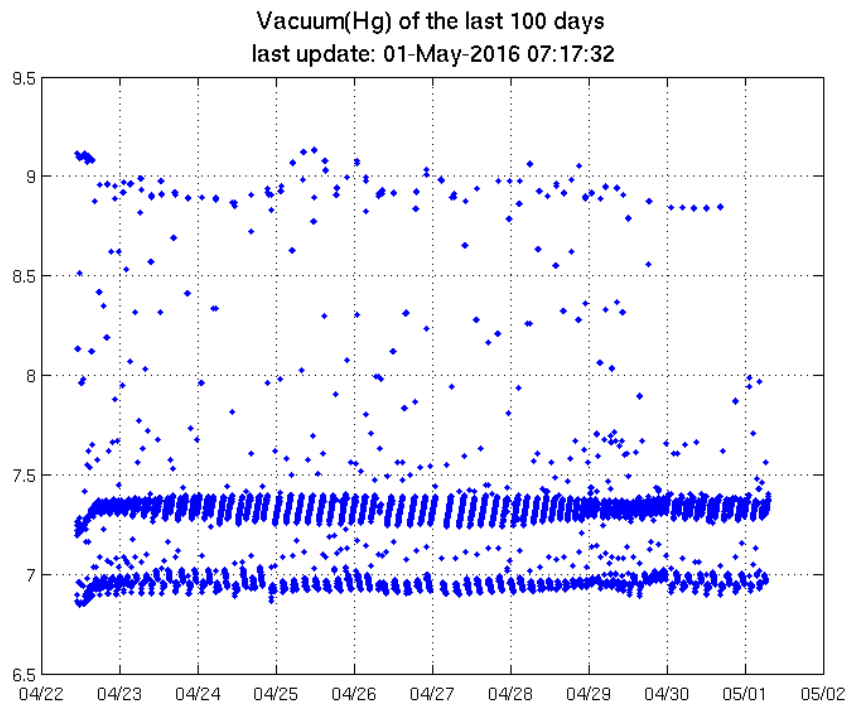
Fig.29 Internal vacuum of the glider during the mission.

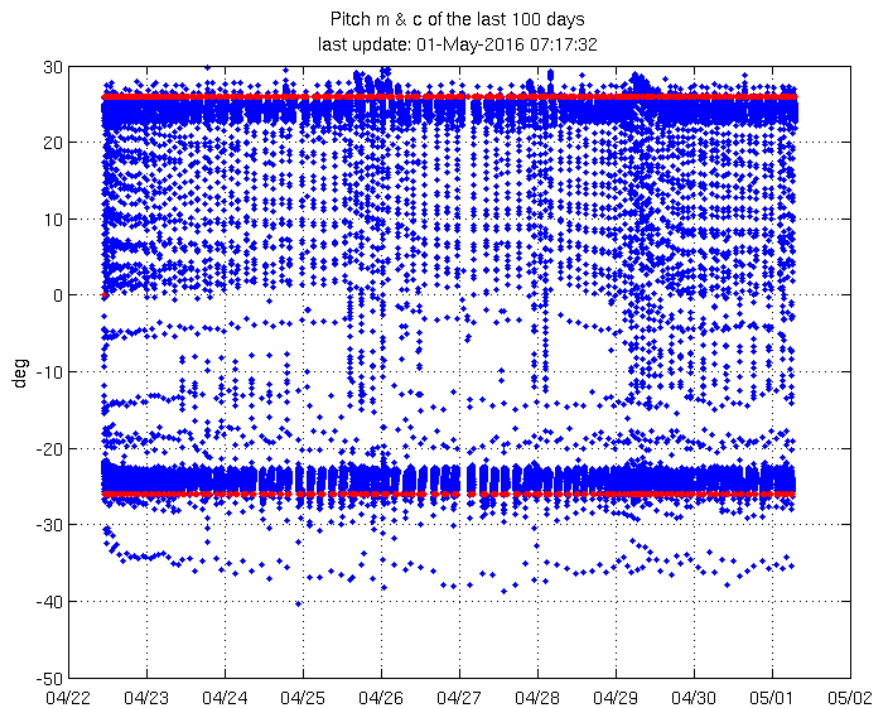
Fig.31 Commanded pitch (red) and measured pitch (blue).

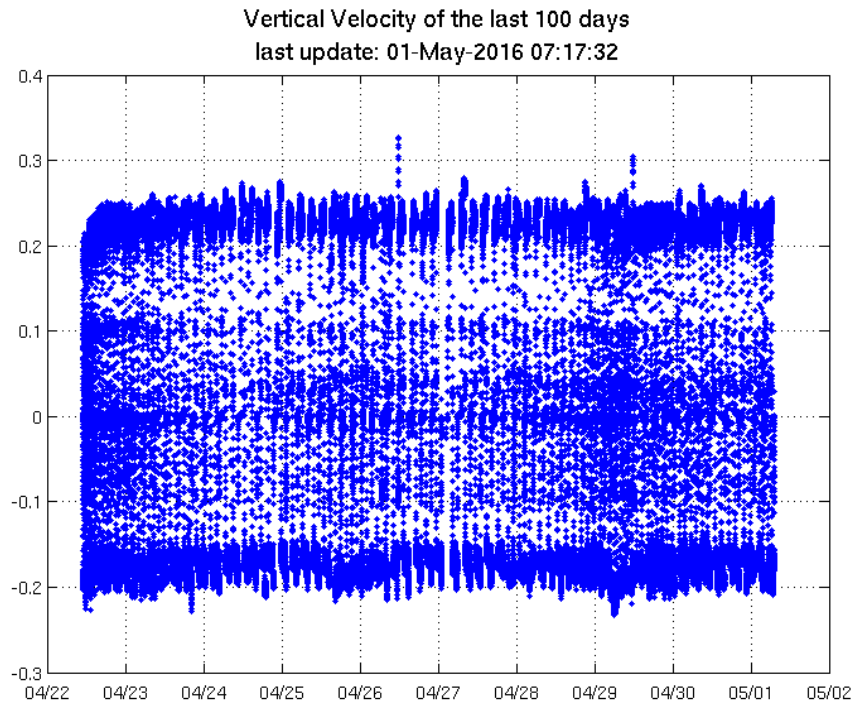
Fig.32 Vertical velocity of the glider as computed by the internal Persistor.
